# Consideration of geological and ecological factors in tourist trail planning: Case study of the Suchá Belá Gorge (Slovakia)

JANA JANOČKOVÁ, MÁRIA KOŠČOVÁ and JANA JABLONSKÁ

*Institute of Geotourism, Technical university of Košice, Letná 9, 042 00 Košice, Slovakia*

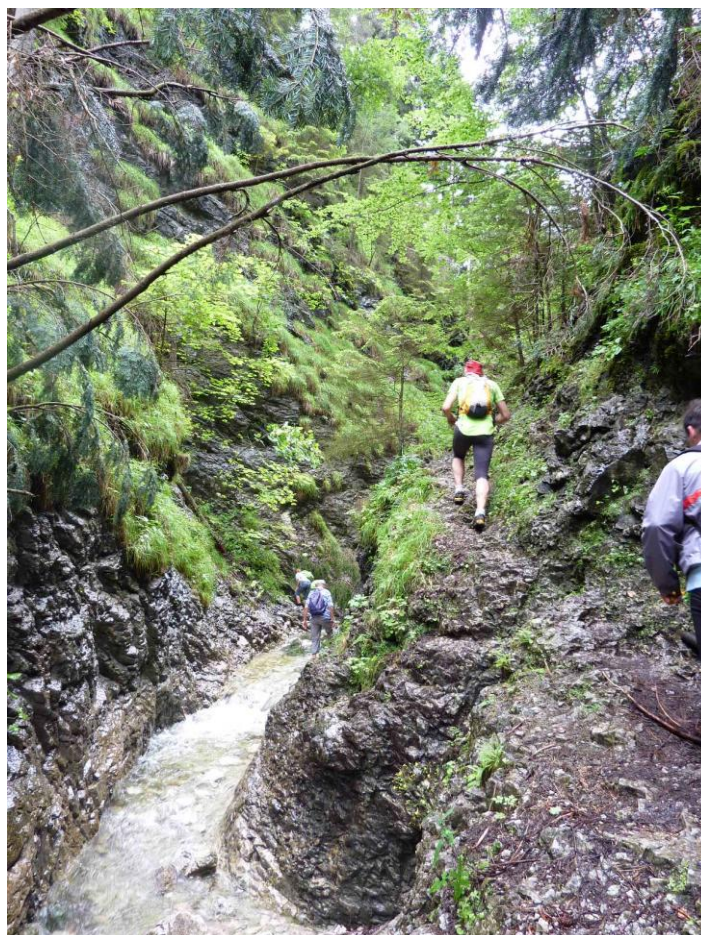
**Fig. 4** Flooded tourist path cause tourists to form alternative paths on an unstable terrain.

The key issue influencing the trail preservation in Suchá Belá is the ephemeral, intermittently flooded streamleading through the gorge. Avoiding the flooded trail results in developing alternative paths on terrains that are unstable and susceptible to erosion and sliding (Fig. 4).

Such illegal paths attract additional use by tourists when the water level falls, supporting landslides, widening of trail sides, trampling of vegetation and exposing tree roots. Therefore the most often flooded trail sections should be stabilised by barriers (Fig. 5), redirected, or crossed/passed over by help of technical infrastructure to prevent off-trail movement.

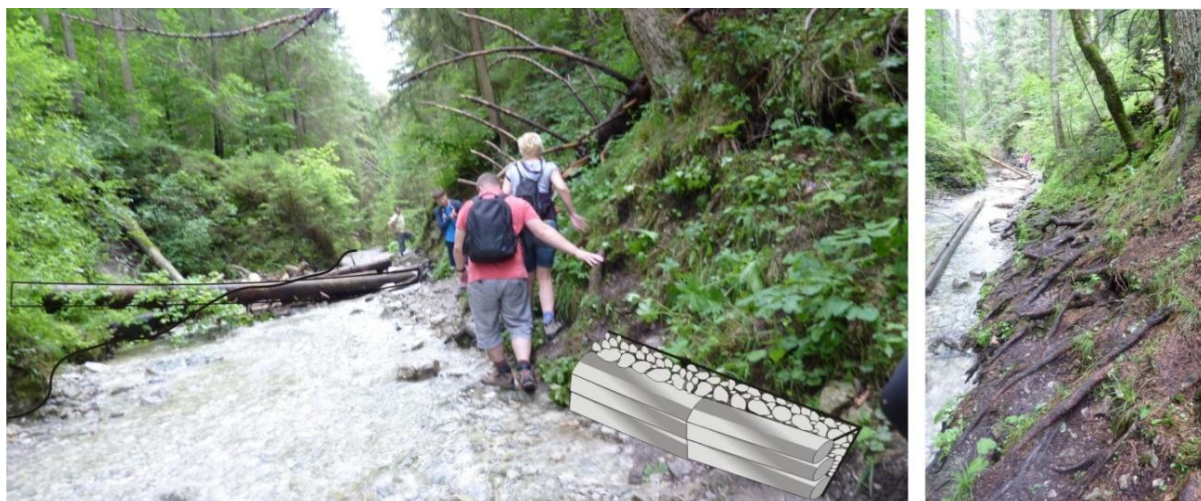
**Fig. 5** Suggested reworking of the trail in the sections exposed to frequent floods. The suggested reworking protects vegetation (see exposed tree roots on the stream bank) and lowers the risk of sliding

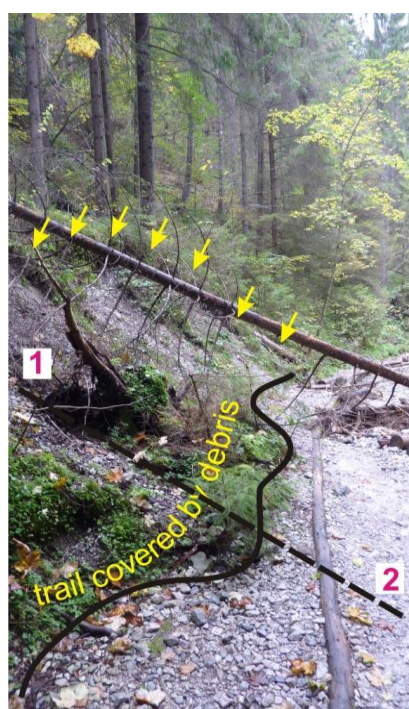
**Fig. 6** Suggested protection of the trail against the rock debris sliding from the neighbouring slopes. The barrier is made from tree logs, arranged vertically and horizontally along the trail. A higher stability of the barrier is assured by inclined crossbar. A) The present state of analysed trail section B) Suggestion of stabilizing the trail.

Rerouting or stabilizing of the trail can also be considered in sections that are repeatedly affected by geohazard activities such as landslides or rock fall, e.g. as shown in Figure 6.
