Stone in architecture and sculpture – source material for reconstruction

Keywords: stone, architecture, sculpture, deterioration, petrography, reconstruction.

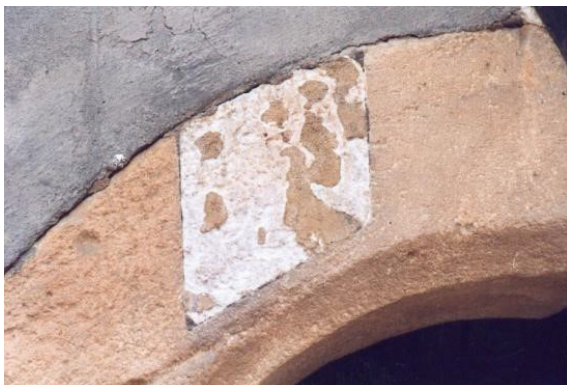
Fig. 2 The application of improper kind of sandstone

and structure of the fillers which obviously reduces aesthetic value of the feature (Fig. 1). In some cases, if the fragments were stones of only similar colour but different mineral composition, less weather-resistant than the original stone, after several years they will differ in, for instance, the presence of secondary mineral crystallization (Fig. 2).

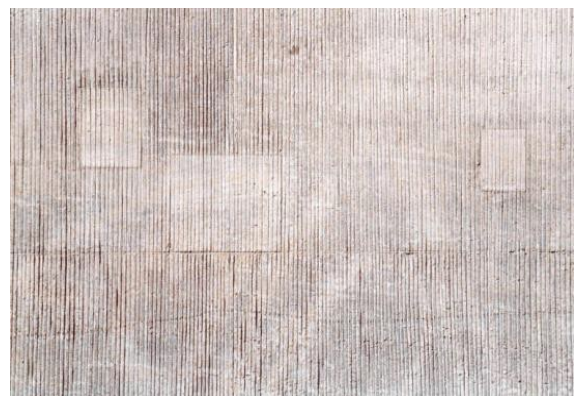
Fig. 3 The application of a proper kind of limestone

Undoubtedly, the best solution is selection of such a stone which will be as similar to the original as possible; and when there is such a possibility, using exactly the same stone (Figs. 3, 4). Although it is often impossible for different reasons, the possibility is always worth verifying (Lorenc, 2005; 2014).

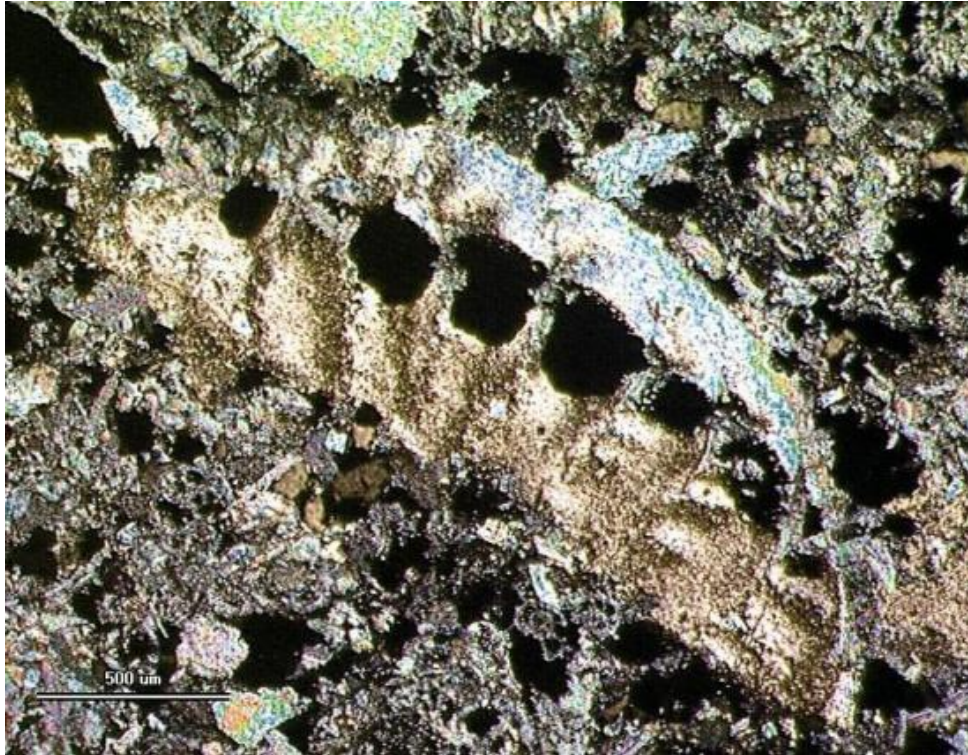
Fig. 7 The structure of limestone. Polarized light, bar. 0.1 mm
